## **7.2 COMMUNICATIONS**

## 7.5 GUIDANCE, NAVIGATION, AND CONTROL

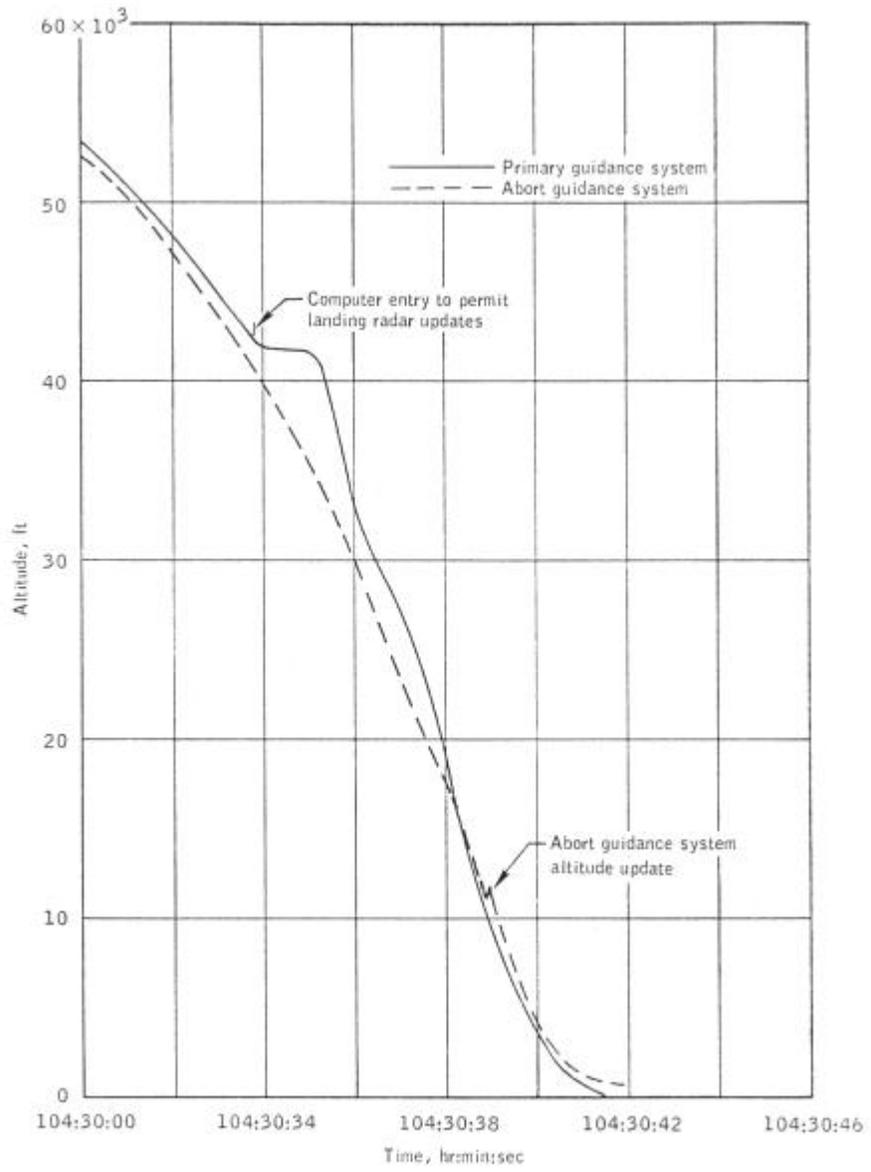
Figure 7-3.- Altitude comparison during lunar descent.
